Manhole Inspection Summary

Manhole # S290__020MH

Insp Date: **5/21/09 10:28 AM**

Location Address: **649 W. HAMBURG ST**

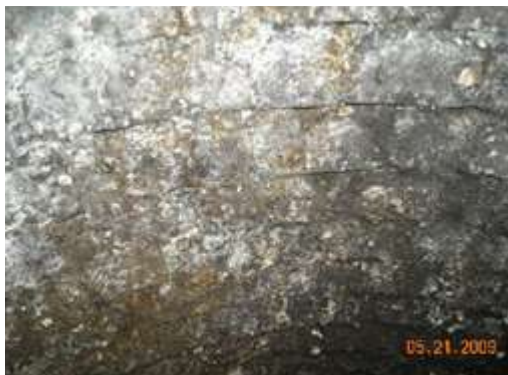
Defect 4

☒ **Evidence Of Surcharge** Depth: **5** (ft.) ☐ Active Surcharge Present

EVIDENCE OF SURCHARGE

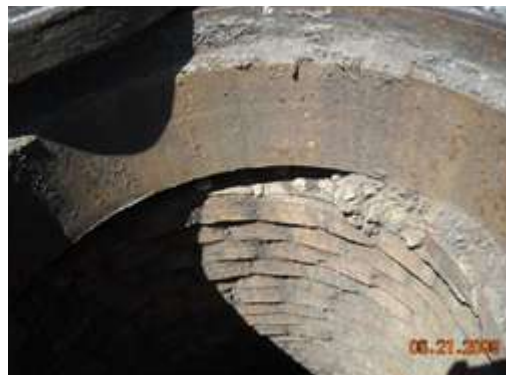
Defect 3

☒ **Leaks**

FRAME LEAKS

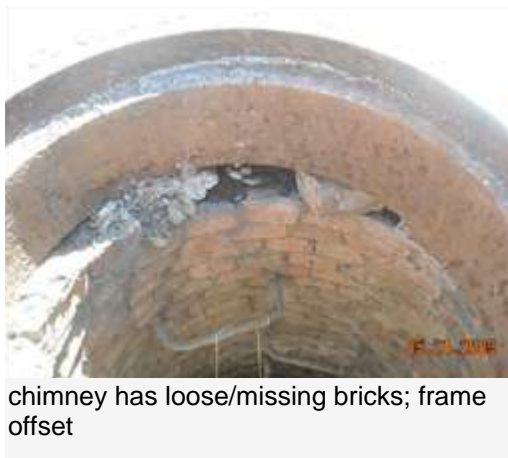
Defect 1

Offset: **1** (in.)

Condition: ☐ Sound ☐ Cracked ☐ Root Intrusion ☒ **Loose Brick** ☐ Deteriorated

chimney has loose/missing bricks; frame offset

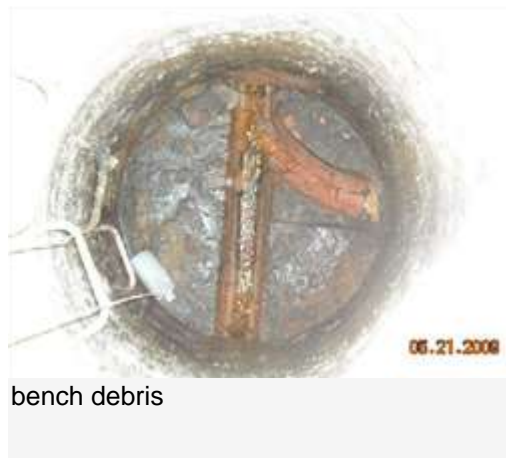
Defect 5

Condition: ☐ Sound ☐ Cracked ☐ Root Intrusion ☐ Deteriorated ☐ Leaks ☒ **Debris**

bench debris

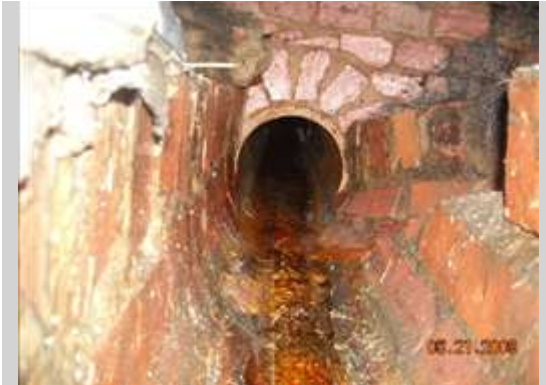
12 O'Clock Outflow

8 in. Circular Gravity Sewer
Pipe Out @ 12 O'Clock

Pipe Height: **12** (in.) Rod and Bar (Angled)
Pipe Material: **Clay** ☐ Pipe Lined
Invert Depth: **9.47** (ft.) Flow Characteristics: **Slow**
Deposits: ☒ None ☐ Mud ☐ Sludge ☐ Debris ☐ Grease
Silt Depth: **0** (in.) Deposits Extent:
Infiltration: **None** Pipe Seal Cond: **Unknown**

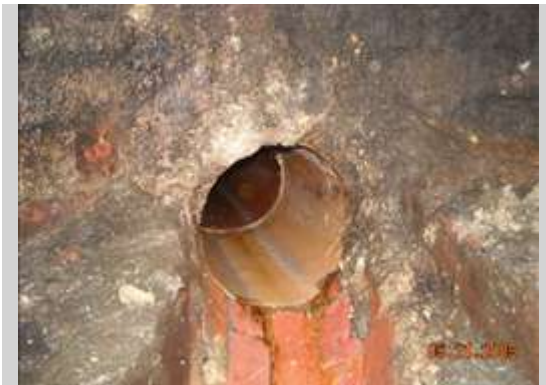
3 O'Clock Inflow

8 in. Circular Gravity Sewer
Pipe In @ 3 O'Clock

Pipe Height: **8.4** (in.) Rod and Bar (Angled)
Pipe Material: **Clay** ☐ Pipe Lined
Invert Depth: **8.90** (ft.) Flow Characteristics: **None**
Deposits: ☒ None ☐ Mud ☐ Sludge ☐ Debris ☐ Grease
Silt Depth: **0** (in.) Deposits Extent:
Infiltration: **None** Pipe Seal Cond: **Unknown**

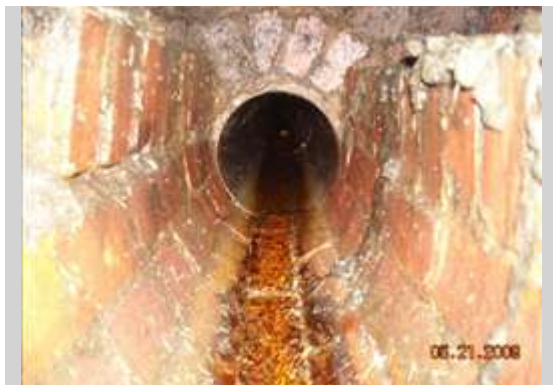
6 O'Clock Inflow

8 in. Circular Gravity Sewer
Pipe In @ 6 O'Clock

Infiltration: **None** Pipe Seal Cond: **Sound**
